# The Associated Satellite imagery and Coastal Radar for Oil Spill Monitoring

Nuttorn Kaewpoo, Siriluk Prukpitikul, Varatip Buakaew,  
Watchara Kesdech and Apisit Kongprom  
Geo-Informatics and Space Technology Development Agency (Public Organization)  
120 Government Building Complex 6<sup>th</sup> and 7<sup>th</sup> Floor,  
Chaeng Wattana Road, Lak Si, Bangkok 10210, THAILAND  
Email: nuttorn@gistda.or.th, siriluk@gistda.or.th, varatip@gistda.or.th,  
watchara@gistda.or.th and nsapisit@gistda.or.th

**KEY WORDS:** Oil spill monitoring, Satellite images, Coastal radar

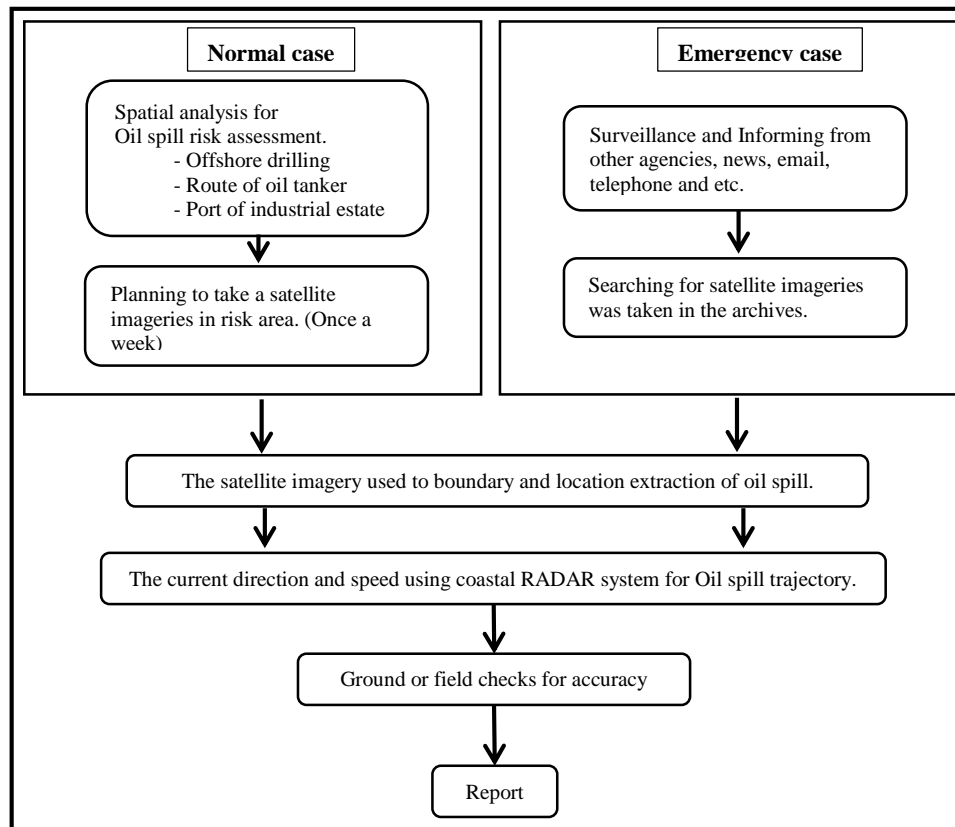
This framework is oil spill processing plan of GISTDA using satellite imagery and coastal RADAR system for oil spill prevention and monitoring.

Figure 2. Oil spill processing plan of GISTDA under Saensuk Municipality Ad-Hoc Operation Center.

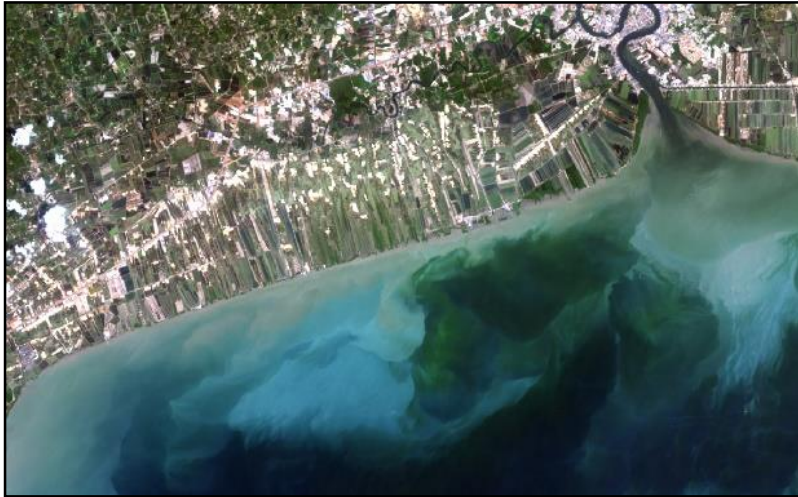
Figure 4. Showing the images from Landsat-8 in true color composite: 4, 3, 2. It is difficult to separate the oil spill area from the sea surface and sediment.

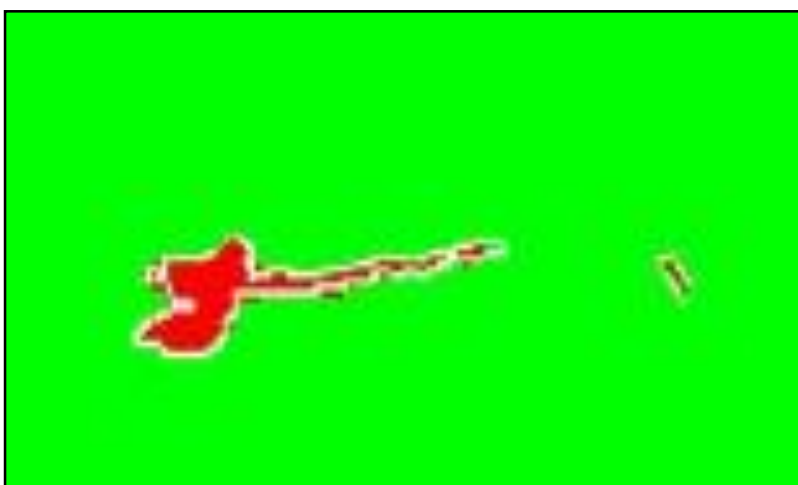
Figure 6. Shows the result classifying areas with oil spill from the sea water with supervised classification method in a red frame showing a red area as the representative of the oil spill area and the green area as the normal sea surface representative.

The study found that the False Color composite of bands: 7,6,4 and stressing on Histograms Equalization expressing showed the clearest spot of oil spill (figure 5 and 6) and later confirmed with an analysis with Supervise classification of maximum likelihood technique. The data accuracy was checked by using data coordinate of the oil spill location obtained from a local agency and the fishermen and get analysis accuracy result of 82%. The area of oil spill was 10.00 O'clock spreading over 0.34 Km and the oil spill moved forwards to the North from the incident point for about 3.5 Km.

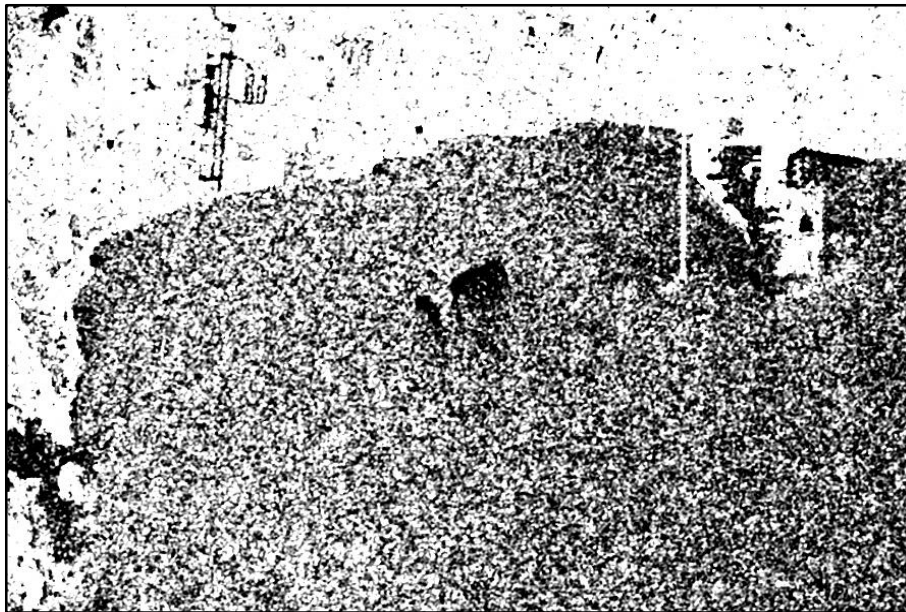
Figure 9. Showing the oil spill boundary from the enhanced image.

The second case, Radarsat-2 image in HV polarization, on 15<sup>th</sup> August 2014 was processed using backscatter detection of different surface roughness. The result shows oil spill boundary on the sea surface 3.5 km. to the south of the beach. The current speed and direction from coastal RADAR system on 15<sup>th</sup> August 2014 were used to predict oil spill trajectory. The trend of oil spill trajectory was from the south to the north and along the Ban Chang beach. The oil spill affected coastal tourism because there are many hotels, resorts, restaurants and nice beach. And the Ban Chang beach was where tar ball and oil slicks were found on 16<sup>th</sup> august 2014 by the local government agency. The accuracy assessment that was validated with data from local government agency is 80%.
